Riparian vegetation appraisal tool

This appraisal tool has been designed to assist dairy farmers in subtropical Australia to better appreciate the impact of past and current farm management practices on riparian vegetation. Use of the tool on different stream sections, or on the same stream section over a period of time, will provide a basis on which to evaluate management practices.

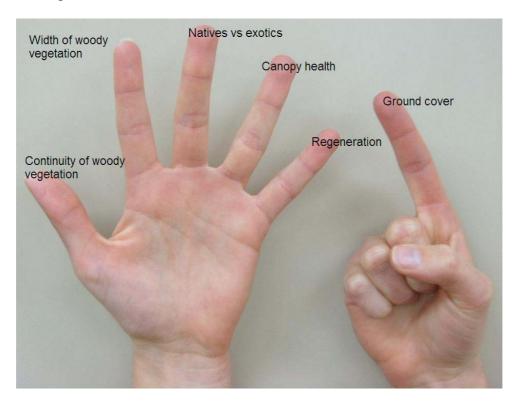
Figure 1: The six features to observe when appraising a riparian zone.

The key features to observe when studying the health of your riparian vegetation are illustrated in Figure 1.

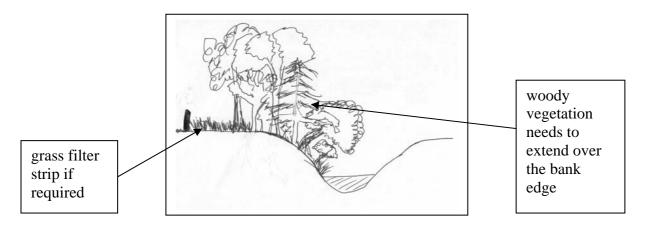
Figure 3. At a minimum, riparian forests need to shade and provide organic inputs to streams, be wide enough to stabilise banks, and be combined with a grass filter strip if overland flow is expected.

At a **minimum**, the riparian zone should be wide enough to stabilise stream banks, provide shade and organic matter inputs to the stream, and buffer the watercourse from adjacent land practices. To achieve these goals, riparian forest (trees, shrubs and ground flora) will typically need to extend over the stream bank and 5 to 10 m onto the floodplain. Where overland flow is expected to occur, there should be an additional 5 to 10 m wide grass filter strip to trap sediment, nutrients and other contaminants.

On high, steep or unstable bank sections, for example, on outer bends, a wider zone (10 to 20 m) of multistorey vegetation (trees, shrubs and grasses) will be required, plus a grass filter strip if necessary.

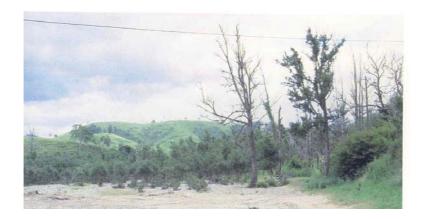
Figure 5. Severe dieback in older Casuarina trees, Mary River near Conondale. (Photo: FR Wylie)

When a tree is healthy, new growth appears all through the crown, particularly at the tips of the twigs and branches. However if the tree is not healthy, the crown will begin to lose its ability to produce new growth. Tree crown condition is a useful indicator of forest health. Crown dieback indicates stress or poor health and can be caused by a number of factors, including old age, drought, insect attack, disease, and changing soil chemistry and structure. Crown dieback is indicated by irregular foliage coverage, gaps in the canopy, new growth from growing points lower down the branches rather than from branch tips and twigs, and ultimately the presence of dead trees/spars. Although death of trees is a natural process and dead branches provide nesting opportunities for birds, extensive dieback indicates a declining health of the riparian zone.

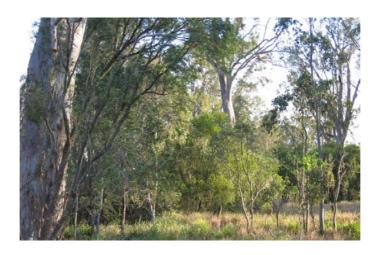
Figure 6. The presence of juvenile trees in this riparian area of a grassy woodlands community is a positive sign for the site's long-term health.

Regeneration is assessed by comparing the stem size of each of the canopy species present. The presence of various stem sizes indicates that a healthy regeneration process is occurring.

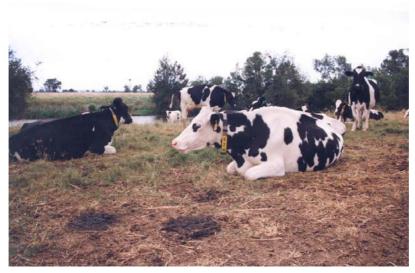
Figure 7. Use of land close to streams for loafing should be avoided to reduce loss of ground cover by grazing and trampling and the risk of contamination of waterways.

Use of the riparian area as a shade, watering and loafing area will reduce ground cover through grazing and trampling by stock. It will also increase the risk of direct fouling of watercourses. The development of alternative shade and watering areas away from the riparian area should be a high priority.
