Naringal

COMPOST PACK BEDDING COW SHELTERS

Clear roofed compost shelter

Simon's farm was visited on the 15th May 2018 and this case study is a summary of Simon's interview and observations made during the site visit.

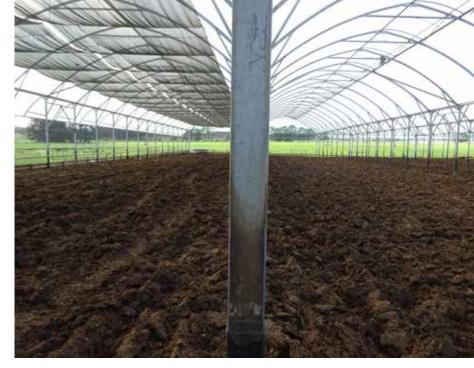
Vents in the roof can be manually or automatically opened to allow hot air to escape when necessary.

The 3-year-old shelter is a 5 X span, 81 X 49m clear roofed structure, with 4m open sides and has a compost bedding area of 4,000m2. The structure is rated to withstand wind speeds of 165kph. Cattle are fed a PMR on a feed pad and trough 40m from the shelter, surrounded by a large loafing area. Vents in the roof can be manually or automatically opened to allow hot air to escape when necessary. Shade cloth underneath the roof can also be extended if necessary, manually or automatically, to reduce solar radiation. The centre bay was designed to convert to a feeding lane if necessary, but feeding on the external feedpad has proved successful. The plastic roof has a life of 10 plus years, and costs approximately \$12,000 -\$14,000 to replace.

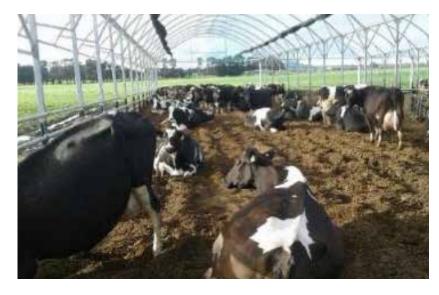
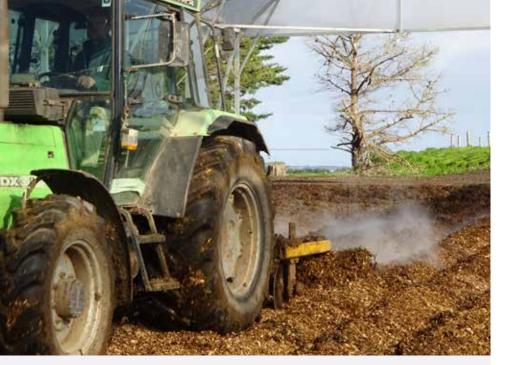
In hot weather, all cows utilize the shelter for the hottest period of the day with air temperatures in the shelter well below the outside temperature.
