Loose housing – with compost bedded pack and loafing

Andrew Tyler – Tongala, North-central Victoria

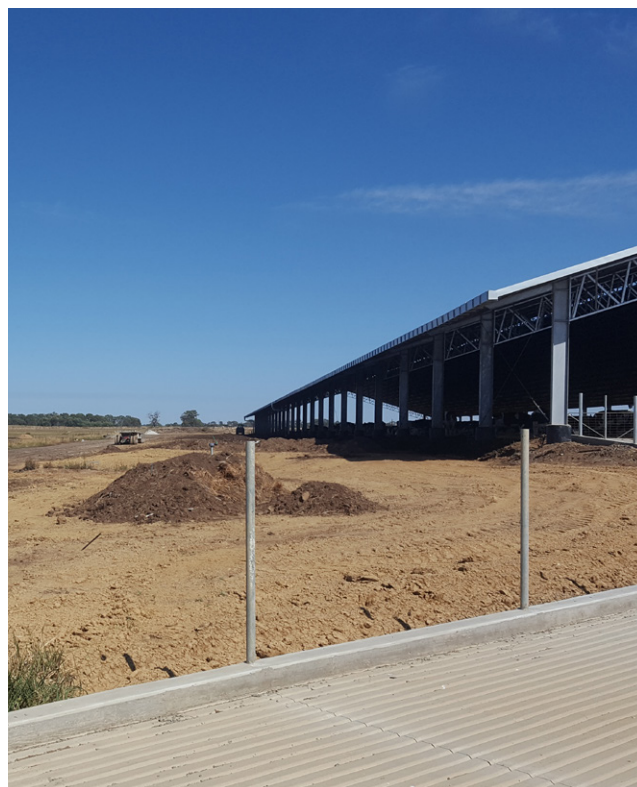
The facility measures 254m in length and 50m in width, including a 2m eave on each side. Its orientation is East-west to optimise shade during the Summer. The feedpad consists of a 6m wide central drive alley, with 6.5m wide cow feeding alleys on each side. The wider feeding alleys allow cows to move more freely past other animals that are eating and transition to a paddock. The feedpad features a flood wash system and has a slope of 0.75 per cent. The cow/feed barrier is made of post and rail, with automated sprays installed to cool cows while they eat in hot weather.

The shed structure is widespan, with an open-web truss and portal frame, topped by a corrugated iron roof with a 21° pitch. The posts at the eaves are 5m high, while the apex of the shed reaches 12m. Additionally, a center ridge vent cover is included to prevent excessive sunlight exposure in the shed during hot afternoons. Tipping troughs have aprons around them to prevent water from splashing onto the compost bedded pack in the loafing areas. Temporary tapes can be used to enclose cows within the feedpad when it is being used to feed PMRs with grazing. However, when cows are housed in the facility, the tapes are removed, granting cows open access to the loafing areas from the cow feed alley located between the water troughs.

The compost bedded pack loafing areas in the shed are not large enough for 900 cows, equating to a stocking density of 8m²/cow, versus the recommended 13-15m²/cow. In 2022, the Tylers experienced problems with wet compost bedding, requiring careful management with more equipment and more staff hours to maintain a dry surface for cows. The bedding at the end of the shed nearest the dairy tends to get damper as cows congregate there before milking. Initially, dried manure was used as bedding. Straw was then added. However, only long straw was available, which made tilling difficult, so a thin layer was used just to provide a dry surface for cows. In the very wet Spring of 2022, the Tylers chose to keep cows in the facility 24/7 rather than walk them through mud to wet pastures. This put additional pressure on the shed's bedding and it became wet, leading to increased mastitis. Fortunately, hoof problems were minimal through the wet Spring. In November 2022, the compost bedded pack was removed and replaced with a 300mm layer of woodchips and some straw. This is tilled twice per day to a depth of 150mm as done previously. This bedding material is performing better despite the added cost of woodchips.

To alleviate pressure on the compost bedded pack, Andrew took action in March 2023 by building up and compacting the open areas on either side of the shed, expanding them to a width of 20m. This created spacious outside fenced loafing areas where cows now have access overnight. In March 2023, following the expansion of the dairy holding yard in 2019 to accommodate 850 cows, the cow transfer lane was duplicated, resulting in dual lanes that facilitate the movement of each cow group between the dairy and the shed. Cows wait for up to 90 minutes in the holding yard before milking.
