Pump Performance Case Study

Peter Smith (Sapphire Irrigation Consulting)

This case study was developed for the Tamworth, NSW, Optimised Dairy Farm for the Smarter Irrigation for Profit Project – Round 1.

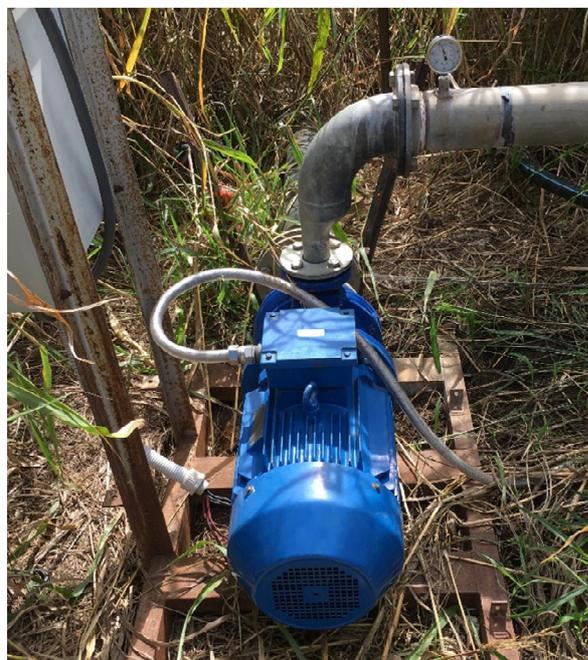
With the new pumping unit installed, the efficiency at both duties showed a marked improvement. When supplying the 'Hill' pivot, the efficiency improved a lot from 46% to 63%. When supplying the 'Flats' pivot, it improved enormously from 12% to 75%.

To improve the performance, the pump was replaced with a new Goulds 80x50-20 and the motor replaced with a new Monarch 18.5 kW at an overall cost of \$8,195.00.
